Sales code: 8VFS2Y Model description: S3 Spb. qu. 2.0 R4213 DSG

Transmission: gearbox warning lamp on, P0C2900 and possibly additional event memory entries - 0GC gearbox

Transaction No.: 2049489/16
Release date 30-Jan-2023

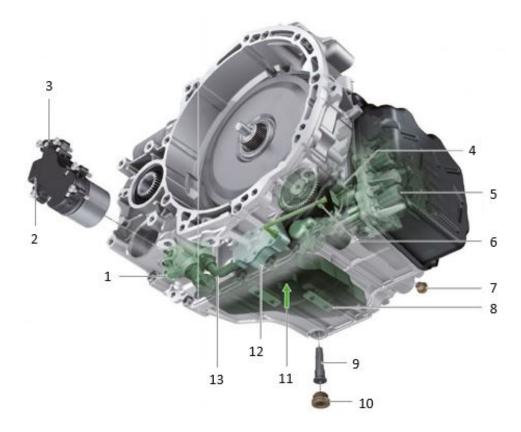
Figure 1 - components of 0GC gearbox

Component-related issue on auxiliary hydraulic pump 1 (-V475-) for gear oil (item 1 - figure 1).

Optimised auxiliary hydraulic pump 1 for gearbox oil (-V475-) introduced

• Replace the auxiliary hydraulic pump according to the instructions in the attachment.

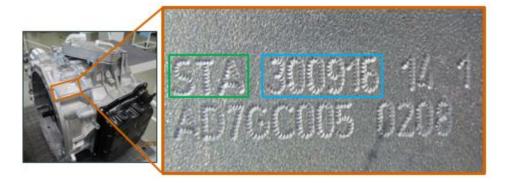
Figure 2 - example of data on gearbox

Gearbox code: STA (green box)

Gearbox production date: 300916 = 30.09.2016 (blue box)

If the gearbox production date is <u>after 26.09.2017</u>, this TPI does not apply. Proceed according to Guided Fault Finding. Please note that in this case the costs for the repair cannot be billed under this TPI.

If the gearbox production date is before or on 26.09.2017, continue as described below.
